**STATE CAPITOL REHABILITATION AND
RENOVATION / CAPITOL SQUARE PROJECT**

**SERIES 2 - WYOMING STATE CAPITOL
SD OWNER REVIEW**

LEVEL III SCHEMATIC DESIGN REPORT
VOLUME I OF III

ASSESSMENT AND RECOMMENDATIONS

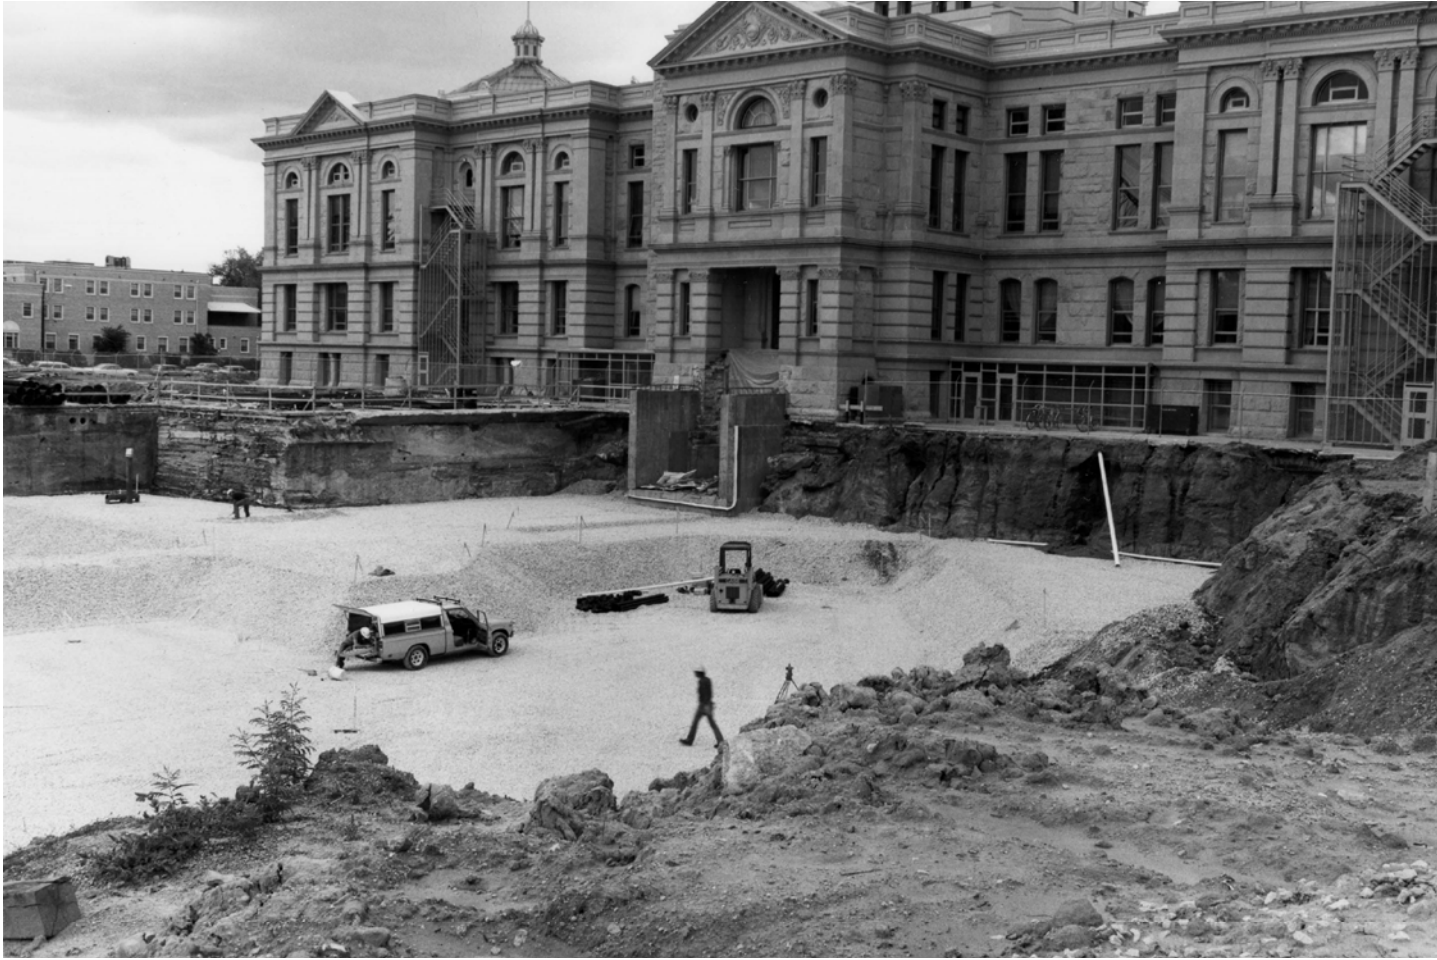
Figure 2.1.6: Disassembly and reassembly of existing north exterior entrance stairs. Note that extensive excavation of the north side of the Capitol was undertaken without staged underpinning.

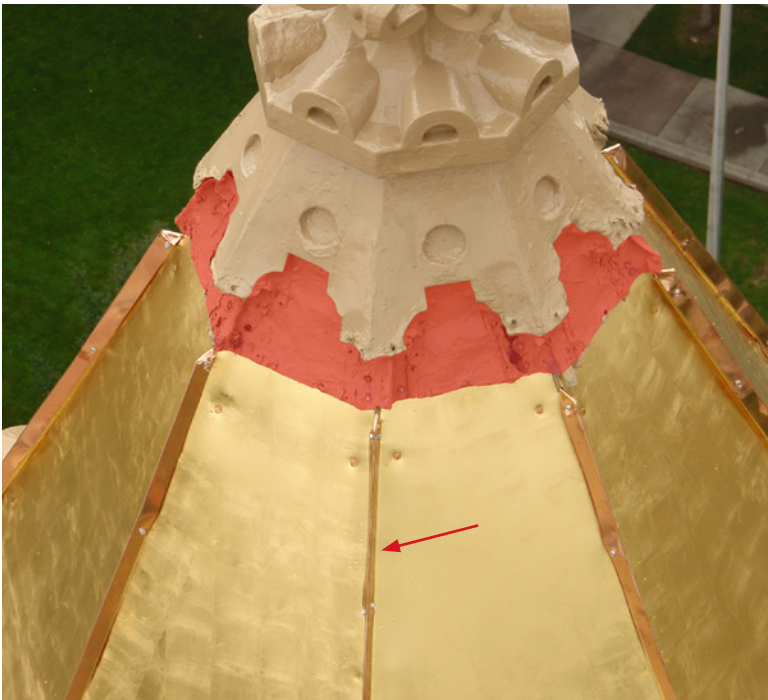
Figure 6.3.3: Top of Lantern. The red areas indicate additional gilded copper area in the historic configuration. The red arrow points to a condition typical at many of the vertical joints which have been filled with sealant, a detail that does not conform to traditional roofing practices.

- The photographs indicate that nails were installed through the gilded copper panels, providing routes for water infiltration [Figure 6.3.4].
 - Sealant was installed at the joint between the gilded copper panel and the top of the galvanized metal lunettes [Figure 6.3.3]. The traditional and watertight detail includes the installation of counterflashing.

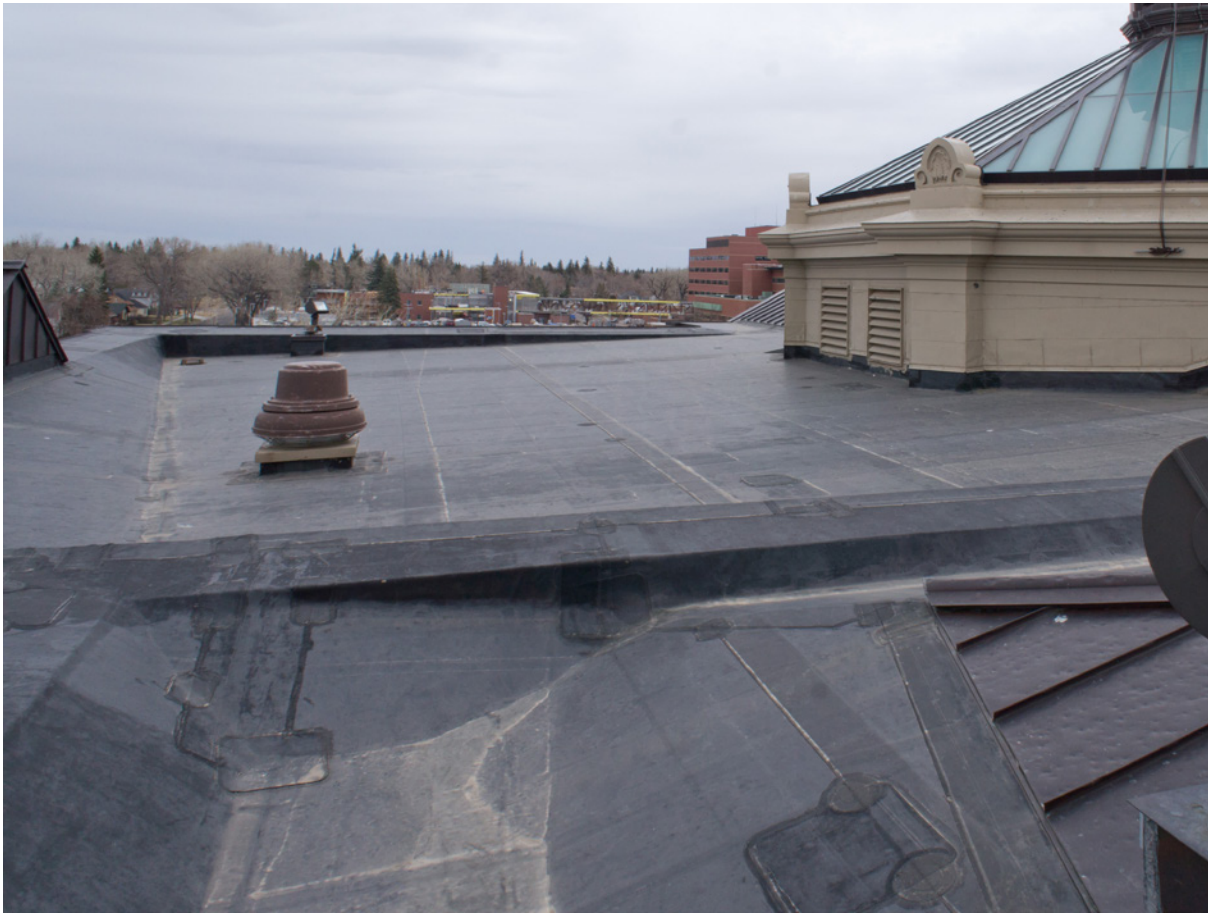
Figure 6.4.1.6 Existing EPDM at Low Sloped Roof Areas and Built-In Gutters.

- Remove existing EPDM roofing and replace with a copper flat lock soldered seam roofing system with traditional / historic copper detailing [*Figure 6.4.1.7*].
- The life span of a flat locked, fully soldered roofing system is approximately 75 years, equivalent to the lifespan of the standing seam copper roof.
- **Seams:** All seams to be crimped with a mechanical crimper. Seams to be peened flat, cleaned and soldered [*Figure 6.4.1.7*].

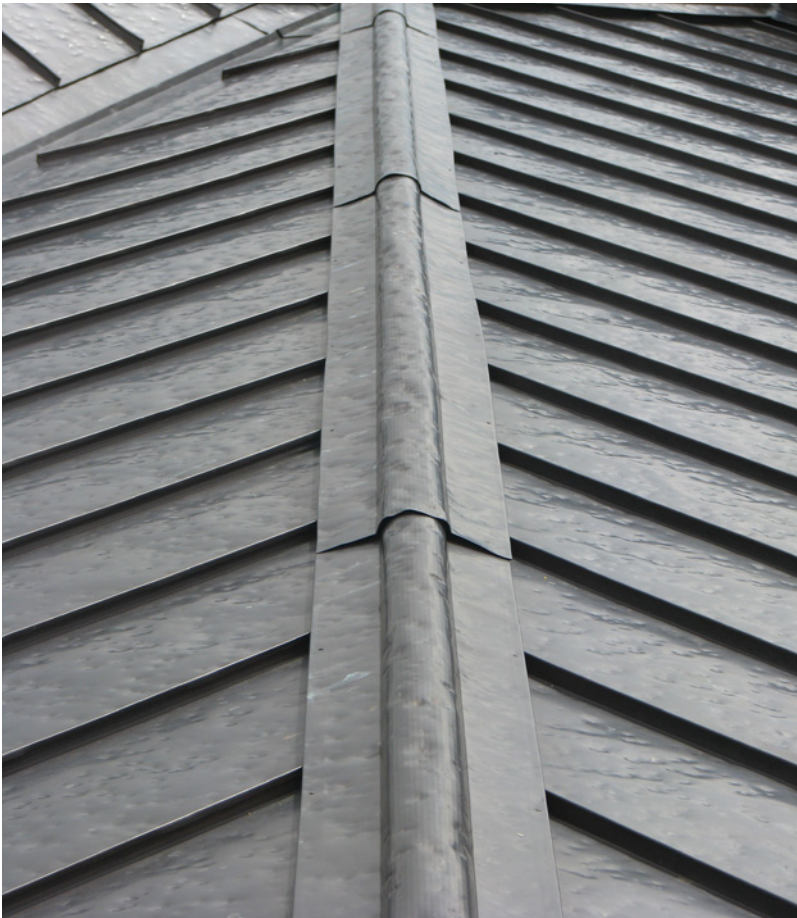
Figure 6.4.1.14 Field Condition at the Ridge Roll and Standing Seam Interface. Note that the standing seams are not laid over at the ridge or hip cap as in the proposed treatment.

- This type of panel termination is typically used on steep “water shedder” roofing systems, such as commercial building canopy roofs, rather than roofs over habitable spaces. This design configuration provides a route for wind driven snow and rain (refer to blue lines in [Figure 6.4.1.15](#)) to travel up beyond the “Z” flashing above the panel, resulting in roofing leaks.

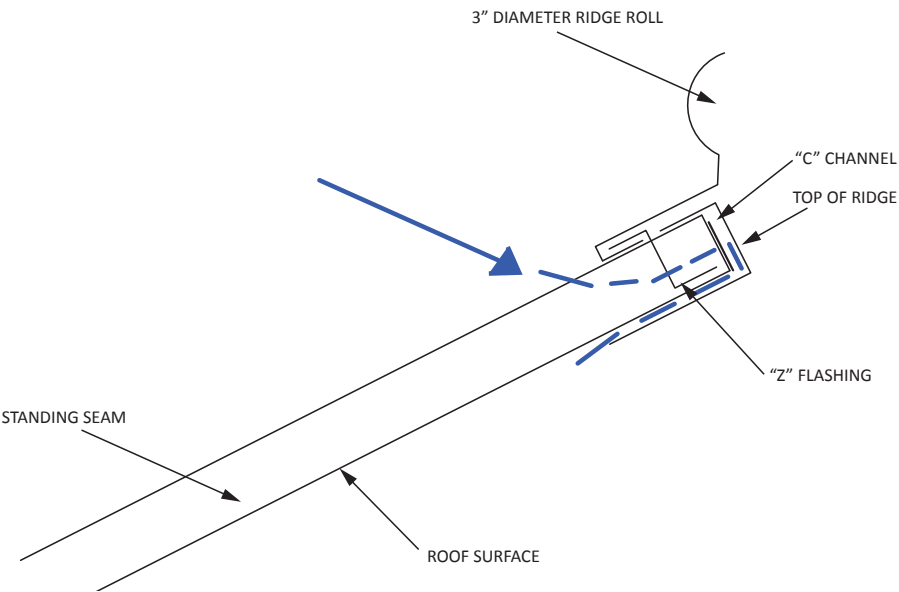
Figure 6.4.1.15 Approximate Field Condition at the Ridge Roll and Standing Seam Interface. The “C” channel at the top of the panel may or may not be present.

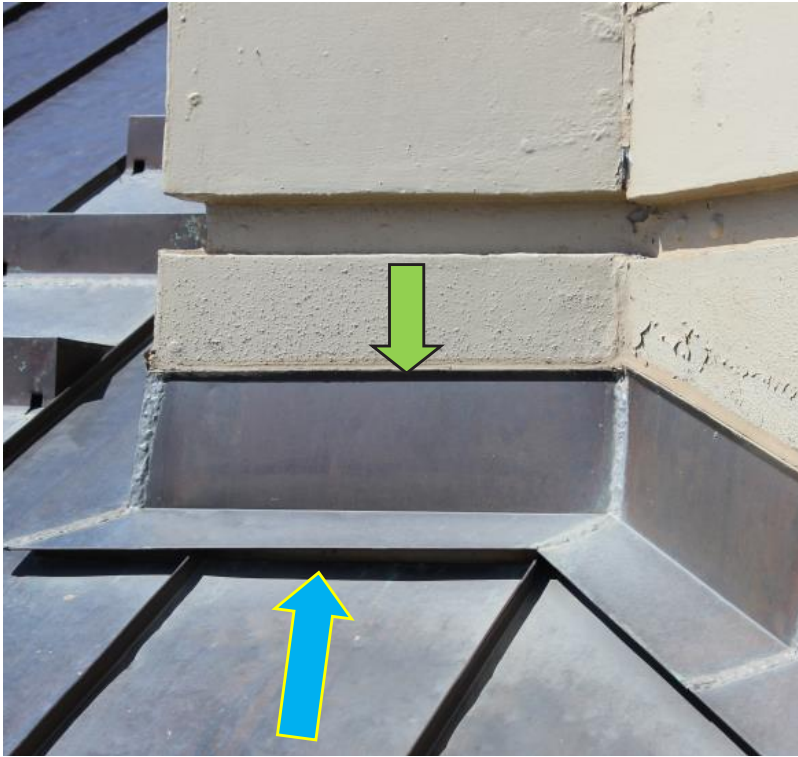
Figure 6.4.1.20 Existing Counterflashing Detail at Cast Iron Drum Base. The green arrow points to the surface-mounted counterflashing. This detail relies on the sealant at the top of the flashing. The blue arrow points to the counter flashing that is hooked onto the “Z” flashing. When this type of detail is used at a roof penetration such as a chimney or cast iron plate, no matter how good the soldering, precipitation will likely enter the assembly.

- A secondary counterflashing should be employed as a primary weather resistant counterflashing. The flashing termination below will be a redundant termination protected from UV degradation.

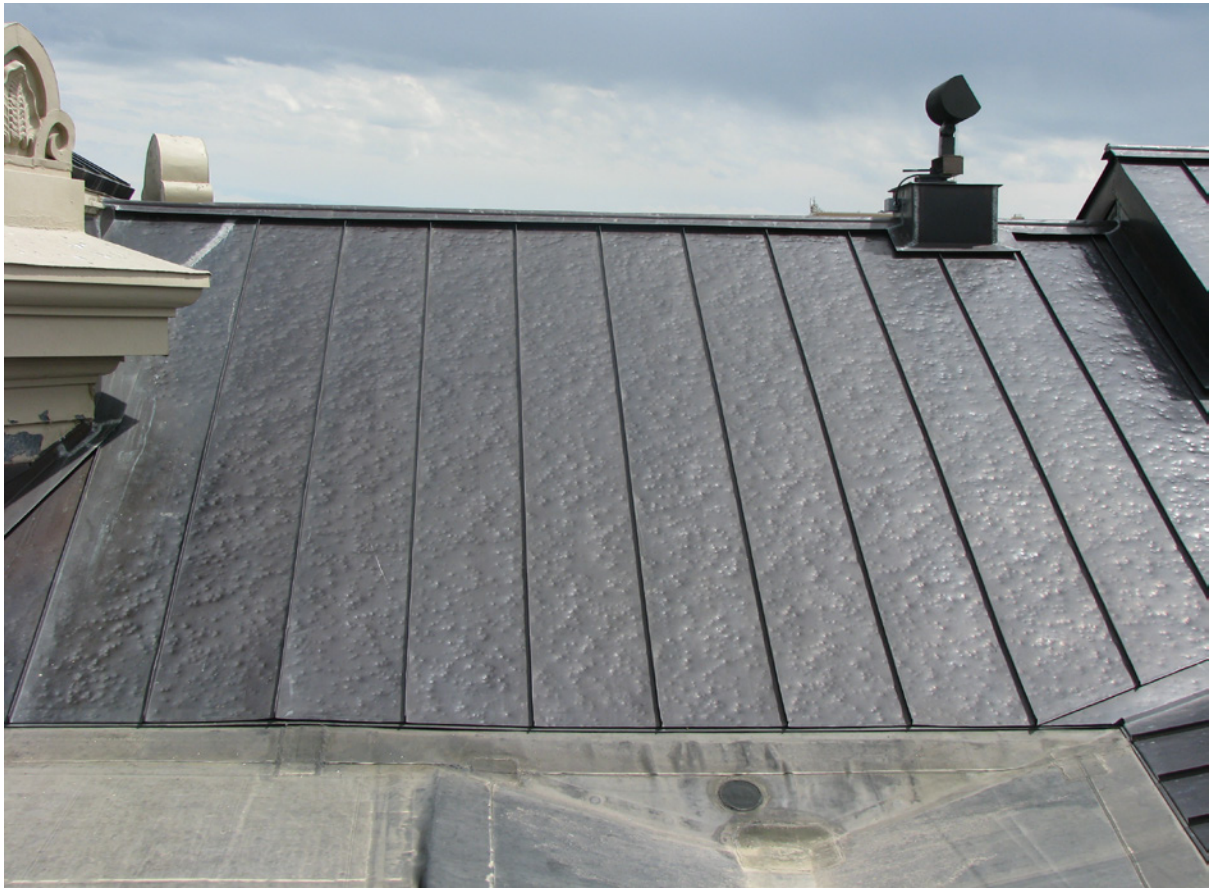
Figure 6.4.1.27 View of Hail Damage at Existing Copper Standing Seam Roofing.

- A contingency should be included for special treatment against hail damage for sheet metal roofing.
- Note to CMAF:
 - Include contingencies for the following items:
 - i. access/catwalks
 - ii. snow guards at pediments
 - iii. fall protection
 - iv. mounting of roof accessories and lighting

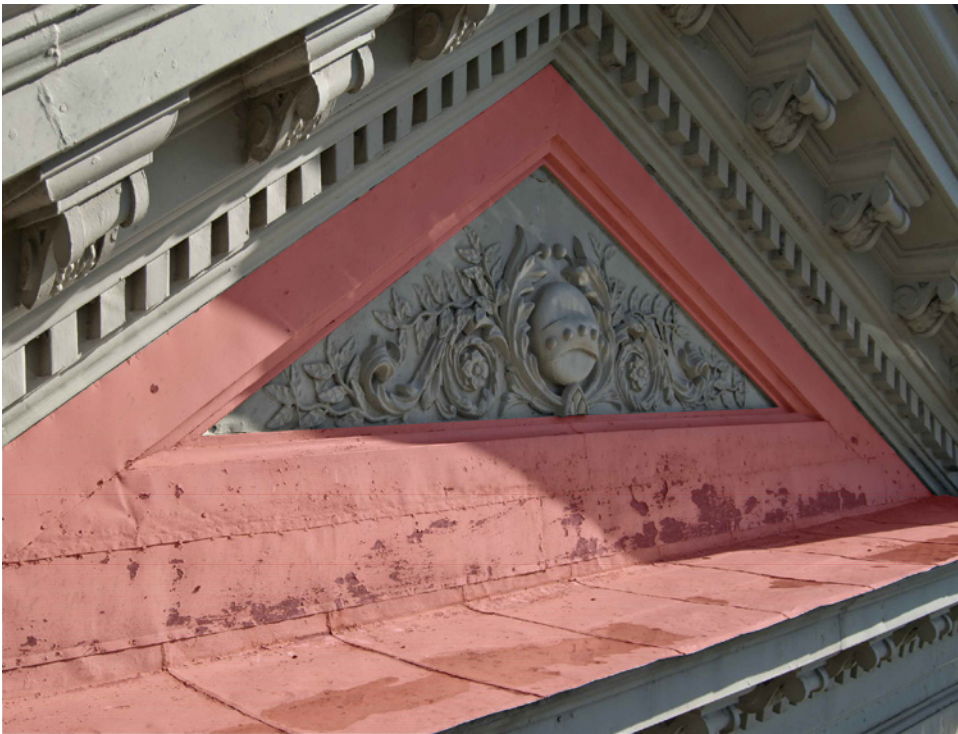
Figure 6.4.2.7 The Areas Shaded Red Are Galvanized Metal Components To Be Replaced With New Galvanized Metal Components At All Pediments.

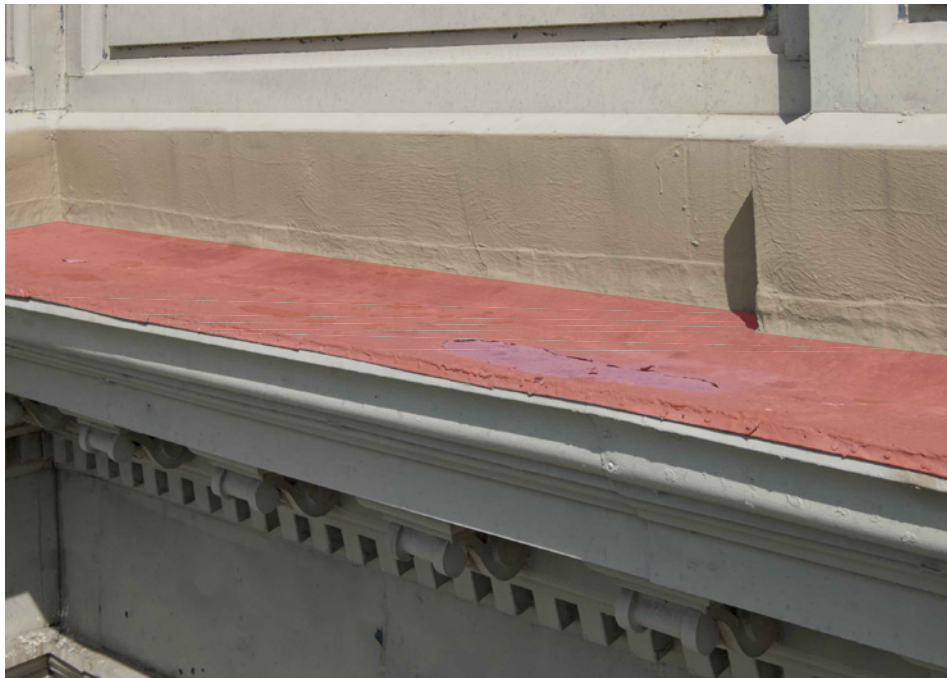
Figure 6.4.2.8 The Areas Shaded Red Are Galvanized Metal Components To Be Replaced With New Metal Components at the Top of the Cornice.

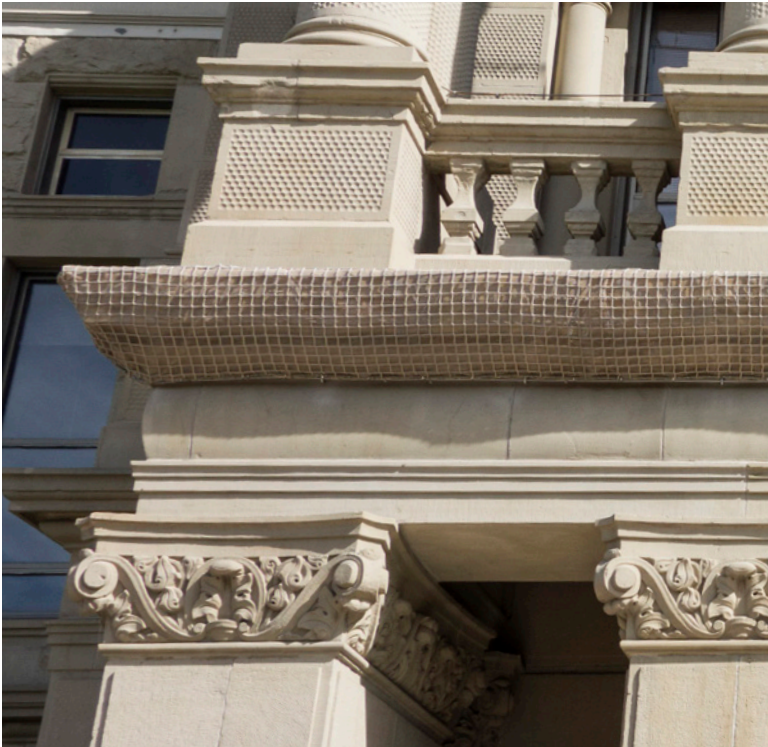
Figure 6.4.3.1: Close-up of the Protective Netting Installed at the Areas of Distress at the Cornice Above the South Entrance.

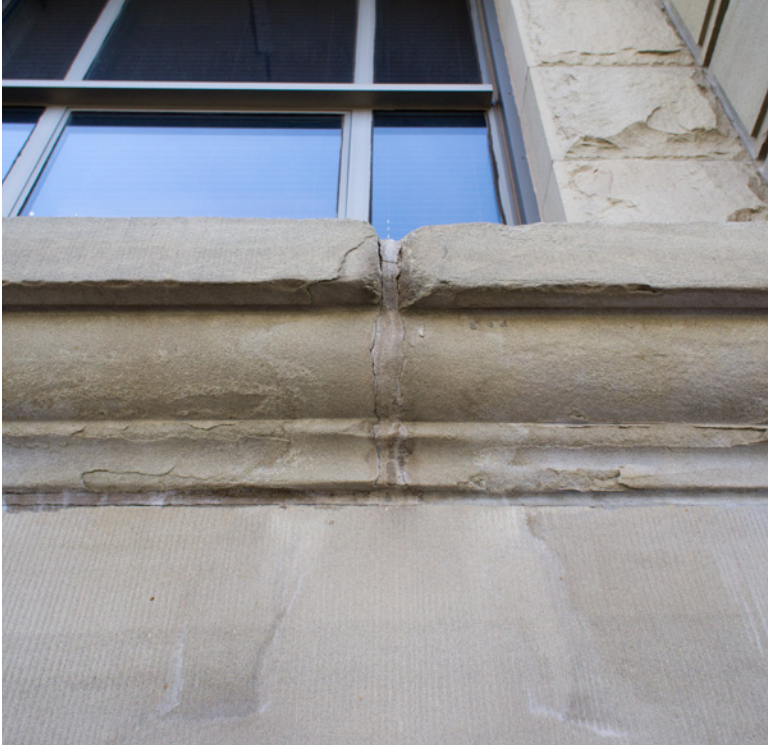
Figure 6.4.3.2: Eroded and Spalled Stone Conditions Adjacent to Open and Deteriorated Joints.

- Repoint 100% of the stone masonry.
- Install lead joint covers at all skyward facing joints at the cornices and other wide projecting elements.

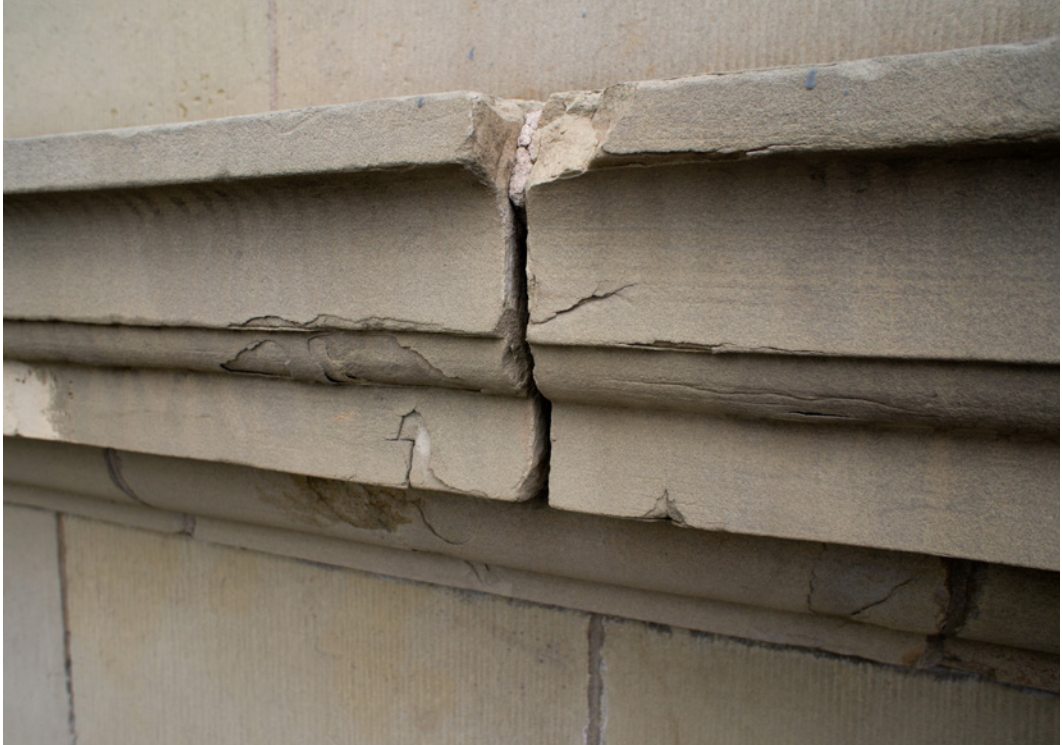
Figure 6.4.3.3: Delaminated, Eroded, Cracked and Spalled Stone Adjacent to Open Joint above South Entrance.

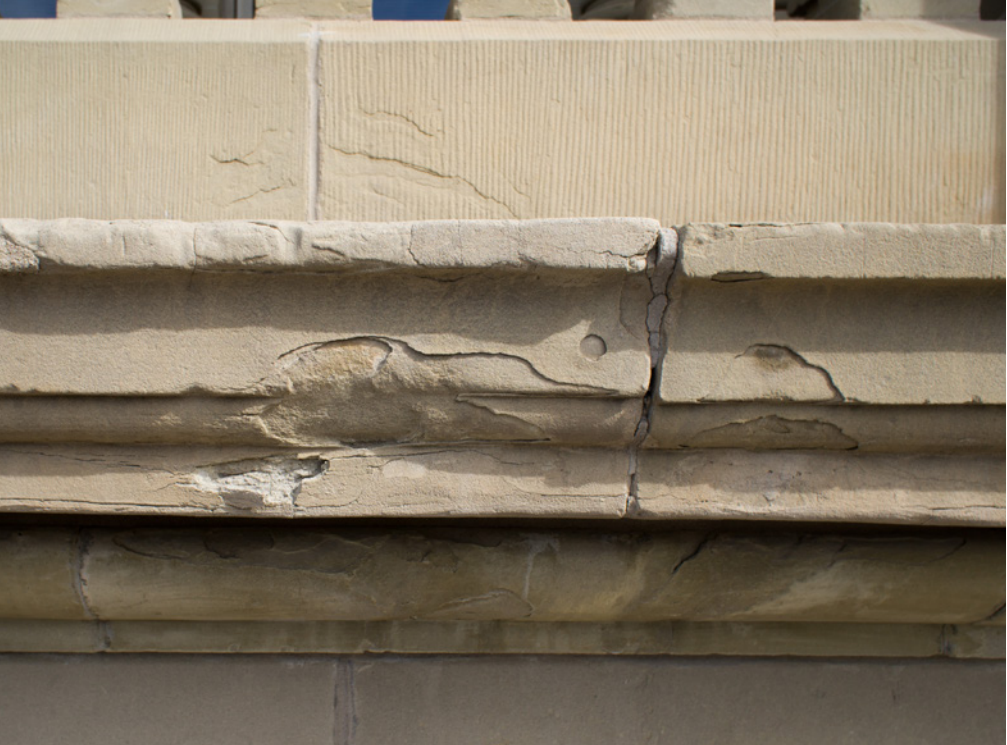
Figure 6.4.3.4: Severely Delaminated Eroded Stone Adjacent to Open Joints at the Cornice Stones Above the South Entrance.

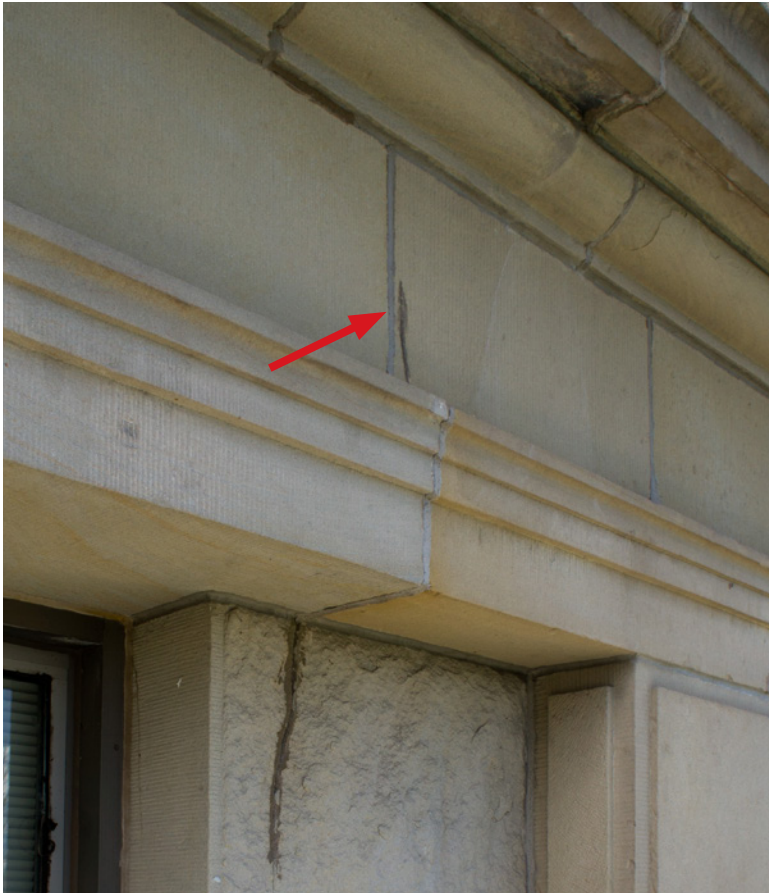
Figure 6.4.3.6: Typical Pattern of Cracking at the East Elevation. At this location, the cracks have been repaired inappropriately with an epoxy material that stains the masonry.

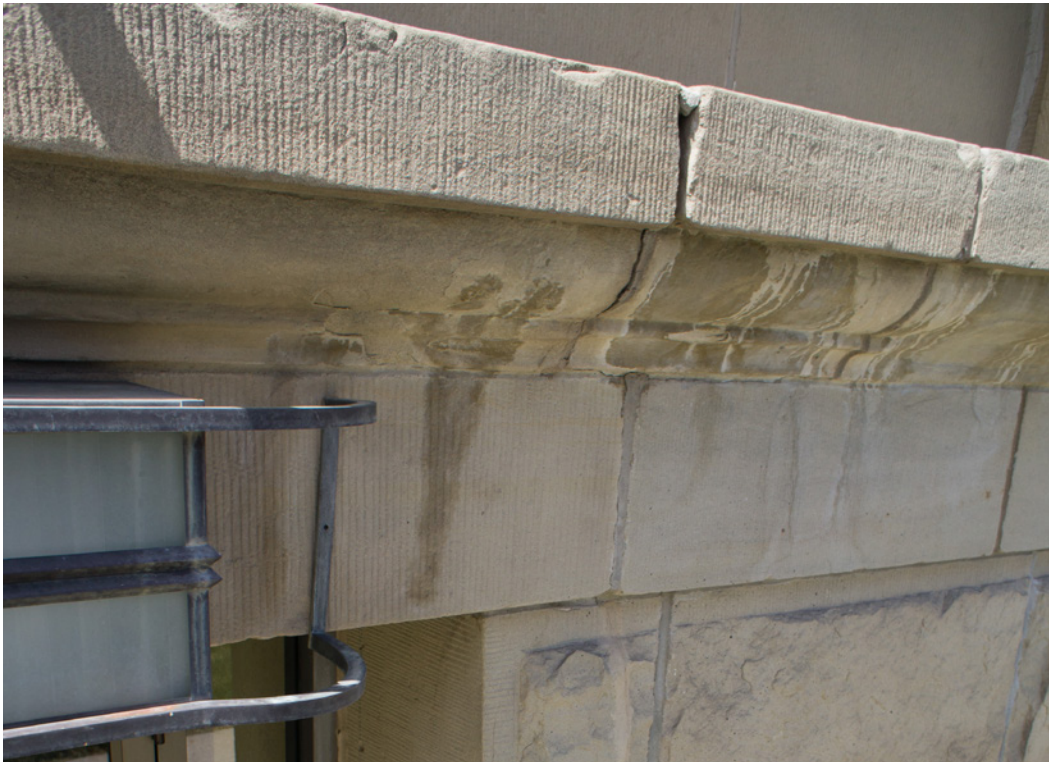
Figure 6.4.3.7: East Elevation Cracked Stone and Mortar Joint at the Cornice above a Cracked Stone Unit That Has Been Repaired.

- At an assumed 70% of cracked stones, repair by cutting out the crack and installing mortar or cementitious grout, matching existing stone color.
- At an assumed 20% of the cracks, cut out the cracked stone and install Dutchman.
- At an assumed 10% of the cracks, pin the cracks as required.
- Replace all of the cracked stone lintels with new stone units.

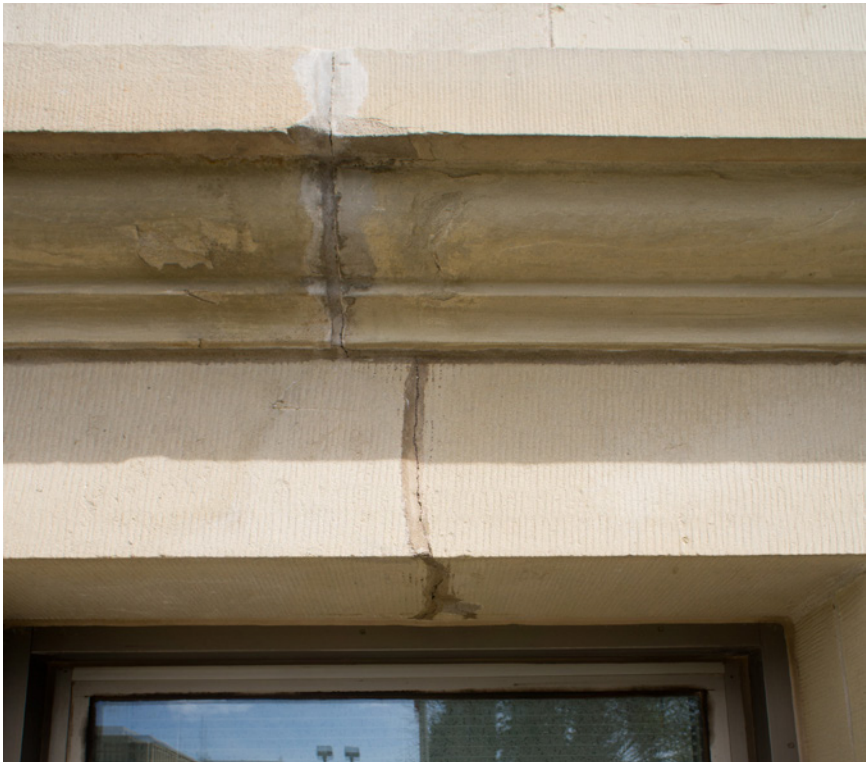
- Cracked stone units were noted at some stone lintels above windows [Figure 6.4.3.8].
- At the bottom of several lintels, there are steel rods, decorative plate washers and nuts visible, which appear to be original, because they are similar to the steel anchor assemblies shown in the historic drawings. There are also steel rods, square plate washers and nuts, which appear to be repairs visible at the bottom of many other lintels. At a few locations the square or rectangular washer has been installed at the crack in the stone lintel [Figure 6.4.3.5].

Figure 6.4.3.8: Cracked Lintel at South Elevation.

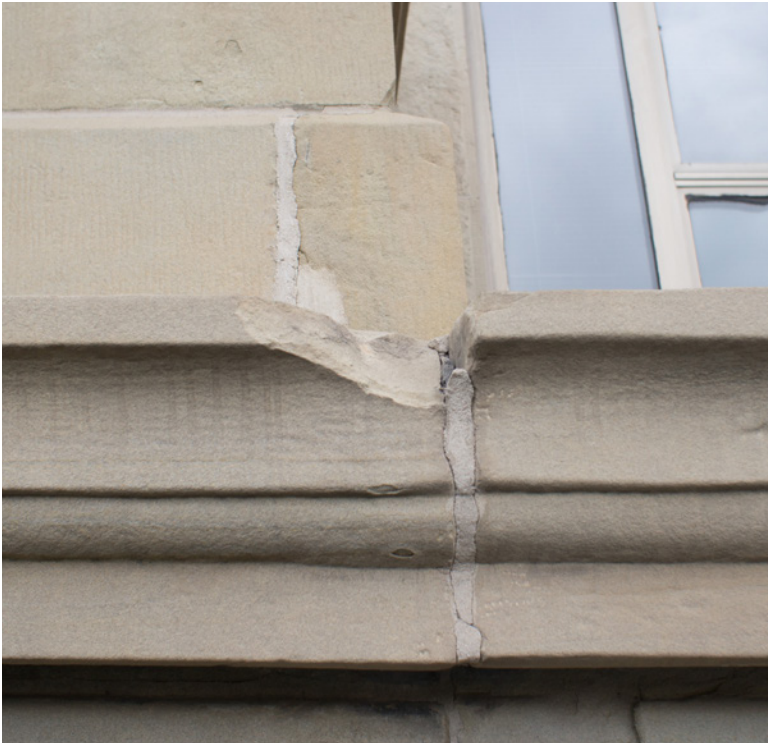
Figure 6.4.3.9: Large Spall Adjacent to a Deteriorated Joint at Projecting Cornices.

- In general, composite patch repairs are not recommended, because typically, they are not a long-term solution. Composite patch repairs may be appropriate at voids that are 2 inches square or less in size. Assume composite patch repairs at all small spalls less than 2 inches square and greater than ½-inch deep.
- Repair large spalls, incipient spalls, or voids greater than 2 inches square and greater than ½-inch deep with stone Dutchman.
- At units with large voids or voids across the entire face of the stone, replace the stone unit entirely with new stone.
- At units with large spalls (greater than 35% of the stone face) and where the integrity of the stone unit has been compromised (at areas of severe delamination; see below for definition), replace the stone unit entirely.

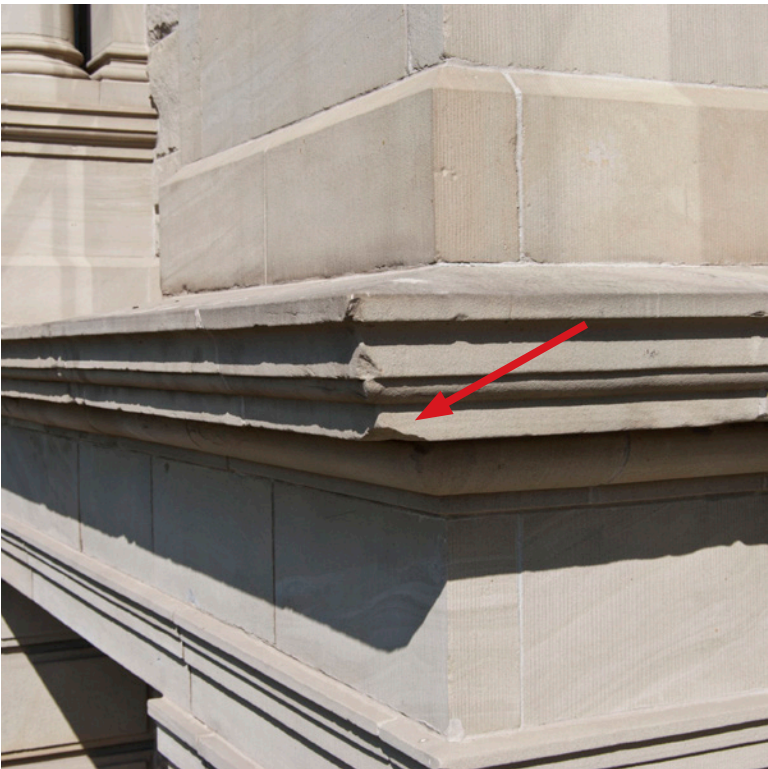
Figure 6.4.3.10: Spalled Stone Conditions at Corner of Projecting Cornice.

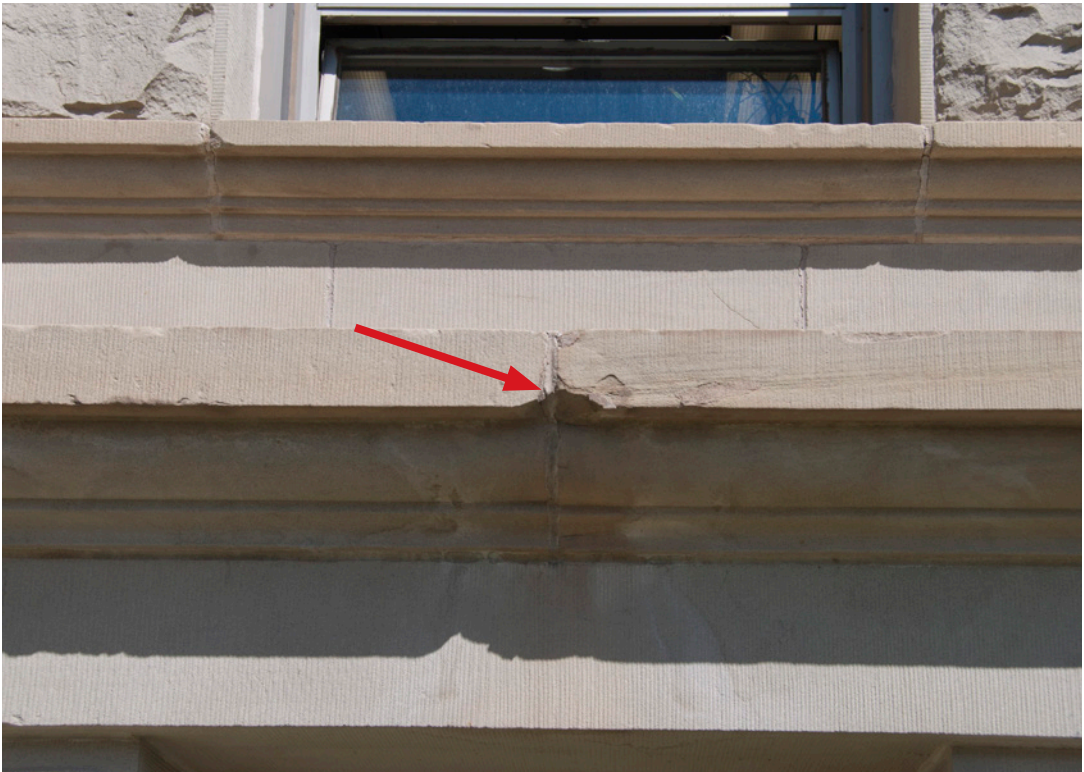
Figure 6.4.3.11: Spalled Stone Adjacent to Open Joint.

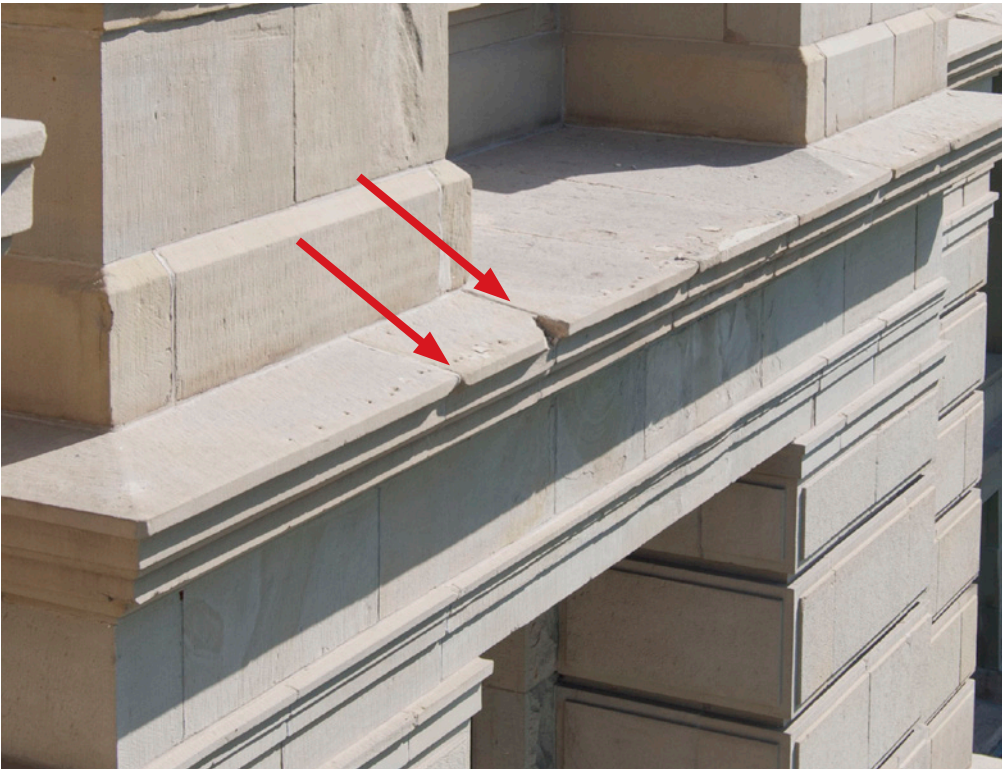
Figure 6.4.3.12: Spalls Adjacent to Open Joints at Cornice.

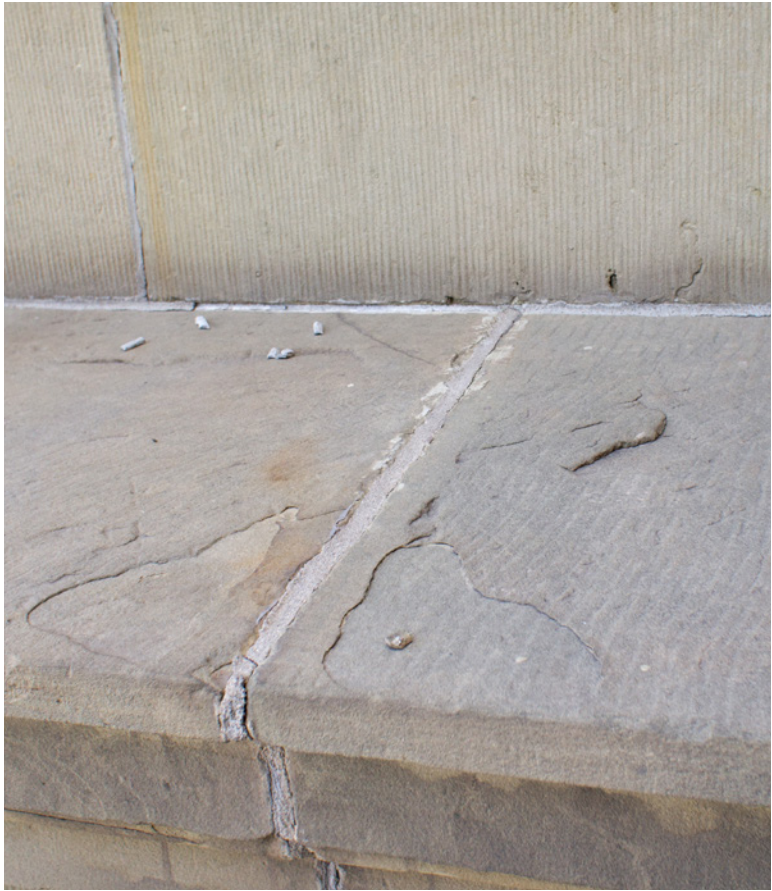
Figure 6.4.3.13: Typical Delamination at Top Surface at Cornice above First Floor Level.

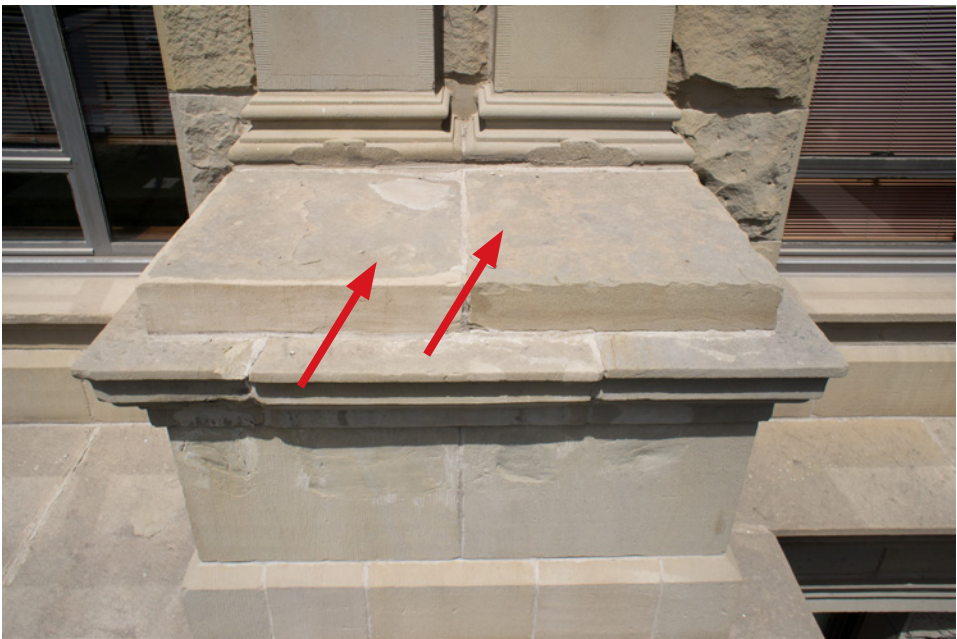
Figure 6.4.3.14: Delaminated, Eroded Stone at Exposed Horizontal Surfaces at the South Elevation. This exposed sandstone element served as a plinth for two columns constructed as part of the 1890 additions. In 1917 the columns were moved to the new additions at the east and west wings.

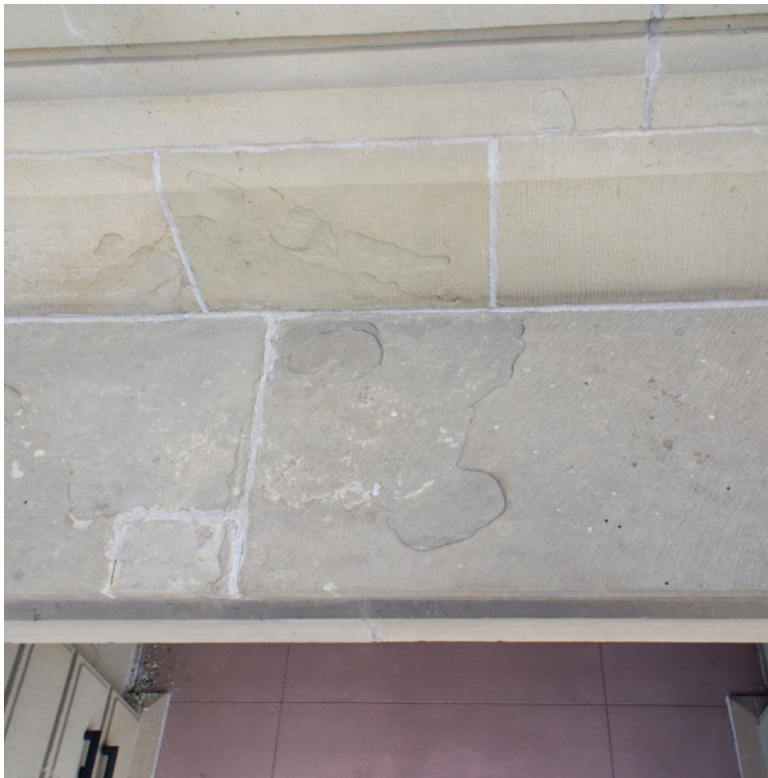
Figure 6.4.3.17: Typical Delamination at Top of Cornice.

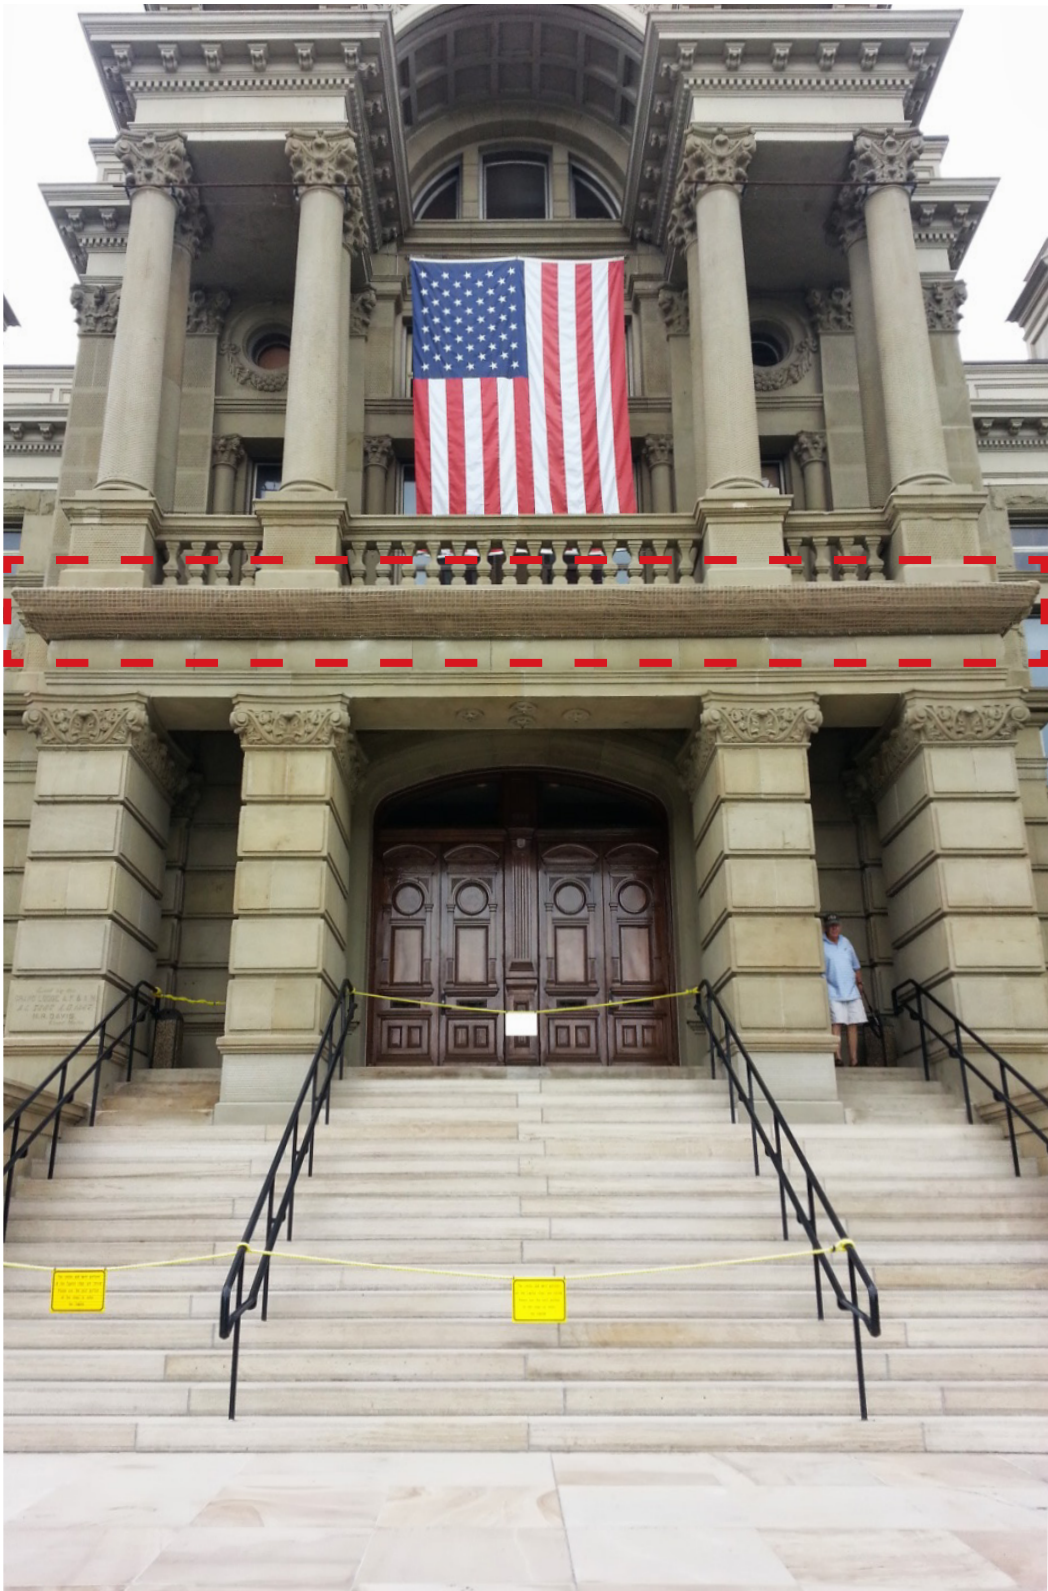
Figure 6.4.3.19: South Elevation, View Looking North. The red rectangle identifies the area of masonry distress and deterioration at the cornice above the south entrance and the protective netting installed as a result.

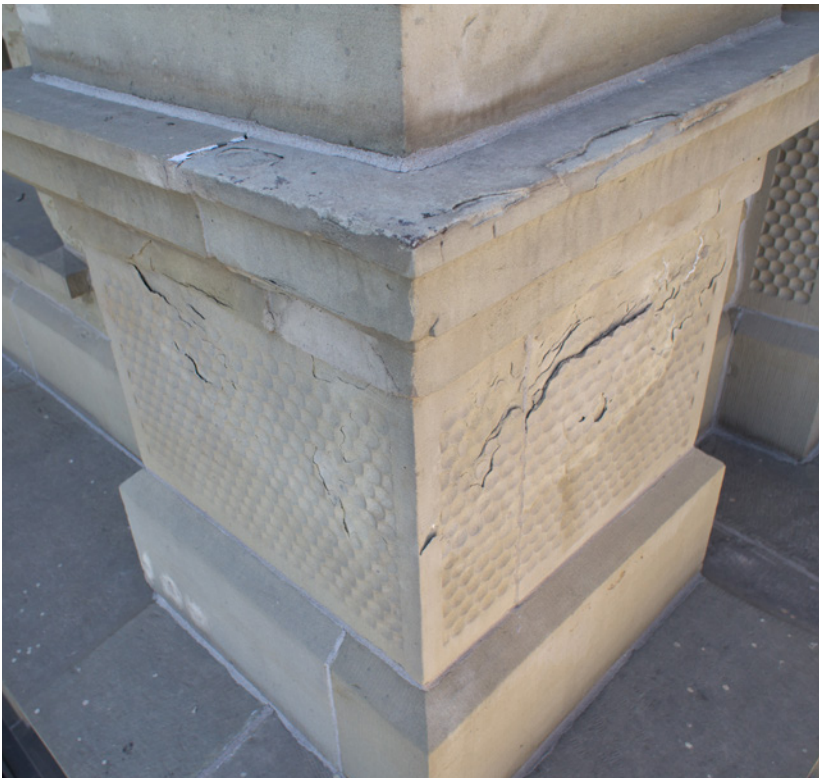
Figure 6.4.3.20: Delaminated, Eroded Stone at the North Portico Caused by Malfunctioning Rain Leaders.

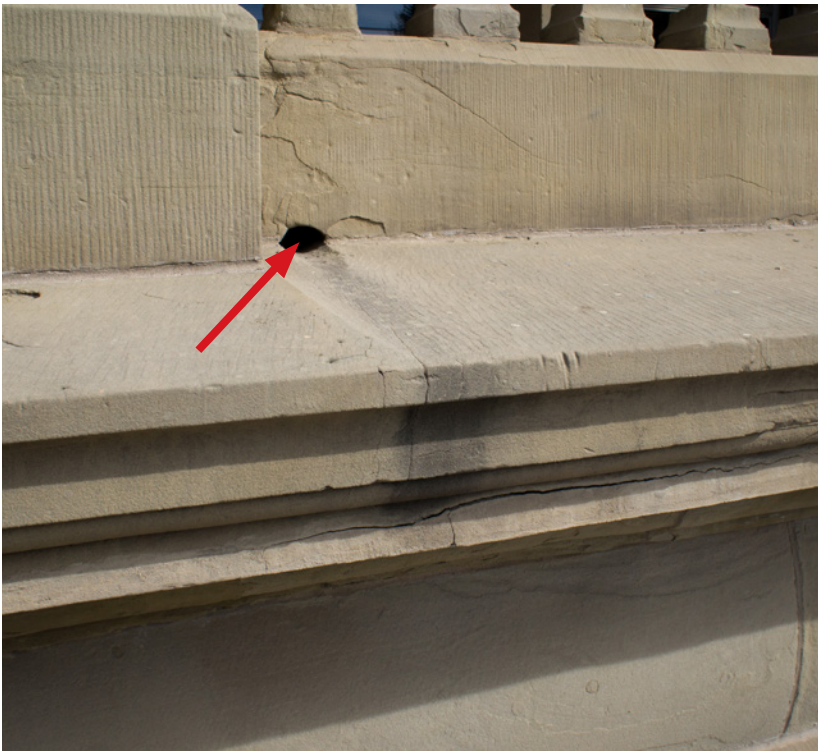
Figure 6.4.3.21: View of the Scupper at Cornice above South Elevation. Note the Stone Deterioration Adjacent to the Scupper.

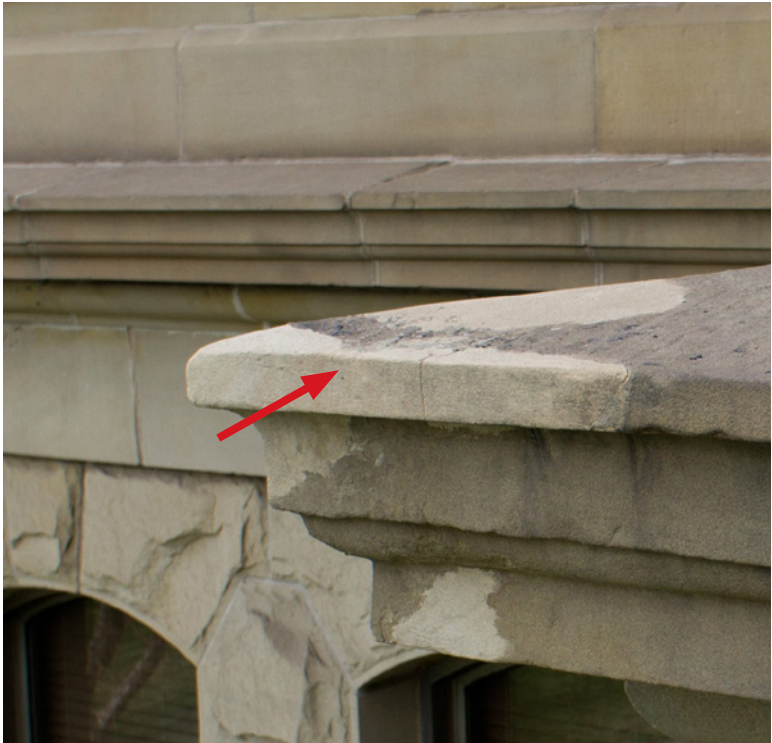
Figure 6.4.3.22: Cracked Patch Repair at the Corner of the Cornice on the North Elevation.

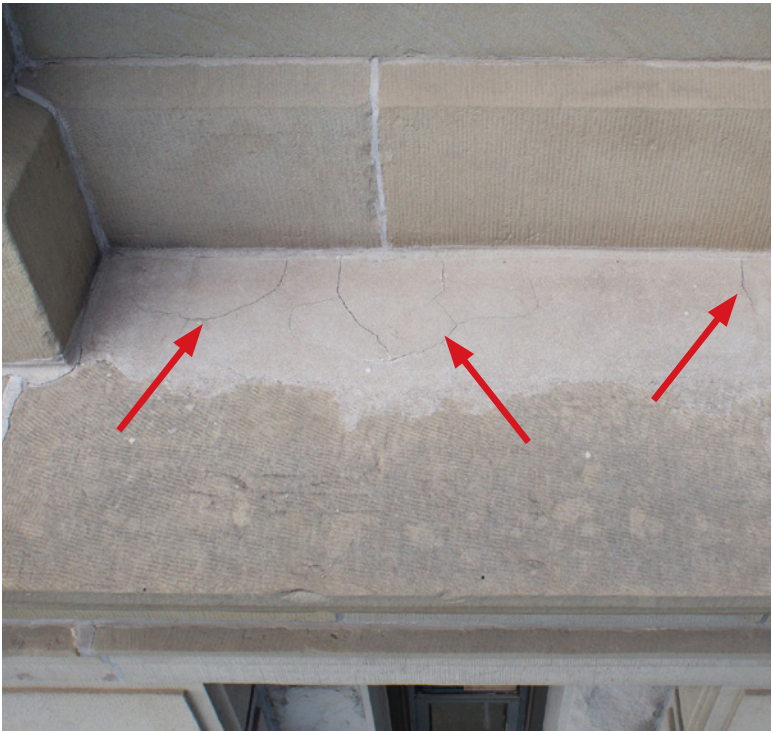
Figure 6.4.3.23: Cracked Patch Repair at the Cornice Below a Window at the South Elevation.
